Subject: BODY VIBRATION AT CRUISE SPEED	Bulletin No: 03-001/06
	Last Issued: 7/21/2006

BULLETIN NOTE

2004-2006 Mazda3

2006 Mazda5

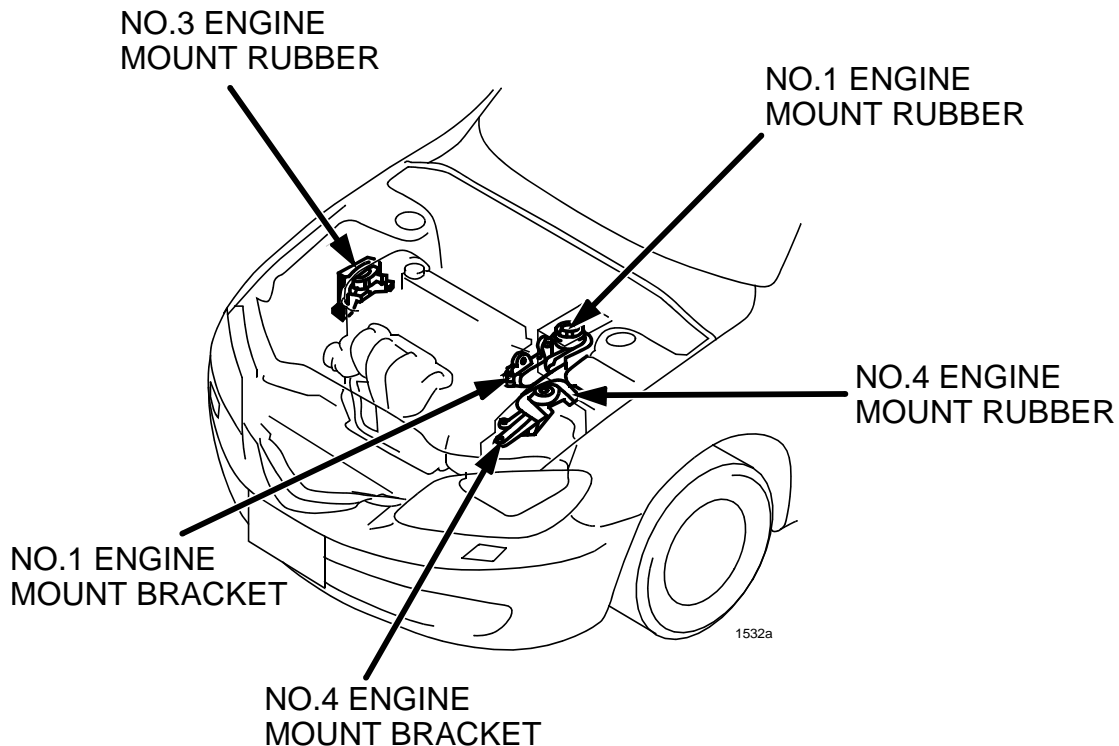
Some vehicles may experience a body vibration when driving approximately 55mph. This symptom is due to the characteristics of the No. 3 & No. 4 engine mounts.

Modified No. 3 & No. 4 engine mounts have been established for service only. Customers having this concern should have their vehicle repaired using the following repair procedure.
