| Subject: LOOSENESS IN RIGHT FRONT DOOR INNER HANDLE | Bulletin No: 09-005/06 |
| | Last Issued: 2/17/2006 |

2006 Mazda5 vehicles with VINs from JM1CR**** ** 109430 to 110624 (produced from September 1, 2005 to September 19, 2005)

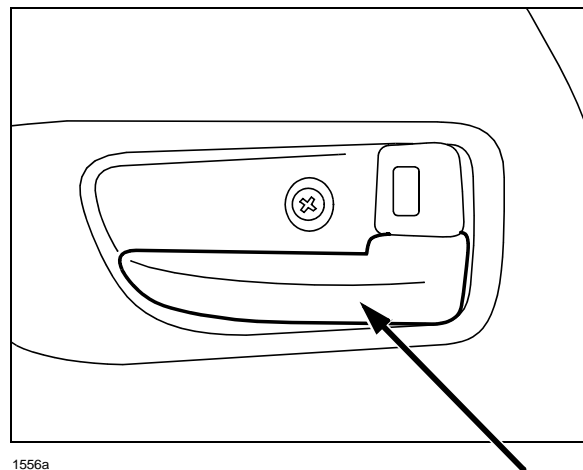
1556a

INNER HANDLE

1. Open the right front door.
2. Open the finishing cap using a small flat-head screwdriver or equivalent.
3. Remove the phillips head screw.

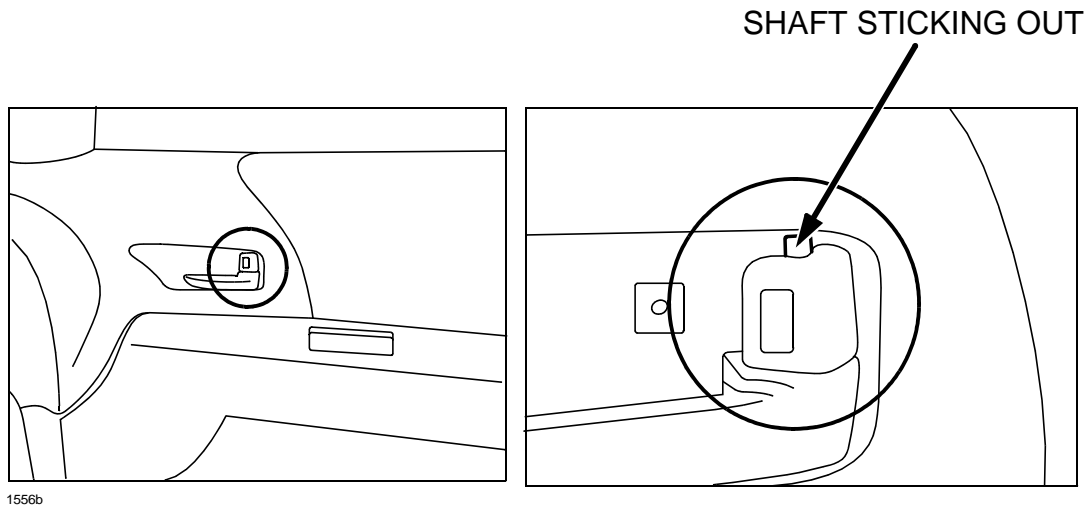
5. Visually inspect if the shaft is sticking out from the lock lever.
- If the shaft is sticking out, go on to the STEP 6.
 - If the shaft is not sticking out, continue diagnosing excessive play condition.
