Subject: FRONT BUMPER REINFORCEMENT RIB - SERVICE TIP	Bulletin No: 09-004/06
	Last Issued: 1/31/2006

2006 Mazda5

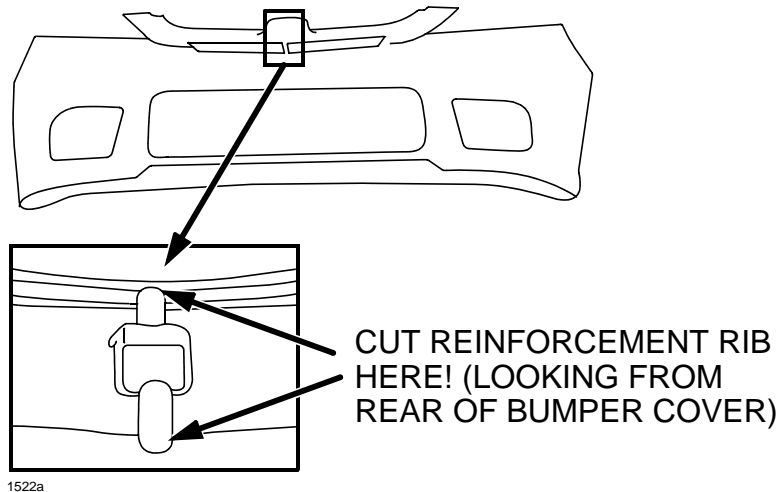
On replacement front bumper covers for 2006 Mazda5 vehicle, a reinforcement rib is manufactured into the bumper cover at the radiator grille opening. The purpose of this reinforcement rib is to prevent deformation during storage and transportation.

This service tip is being provided to outline proper removal of this reinforcement tab.

When preparing and installing a new front bumper cover (CC53-50-031C AA) to a vehicle, paint the bumper cover first, then remove the reinforcement rib. If the reinforcement rib is not removed from the bumper cover, the radiator grille will not be able to be installed.
